# Above Ground Storage Tanks: Repairing Roof Top Leaks In-Service

**Company:** National Cooperative Refinery Association (NCRA) - McPherson, Kansas

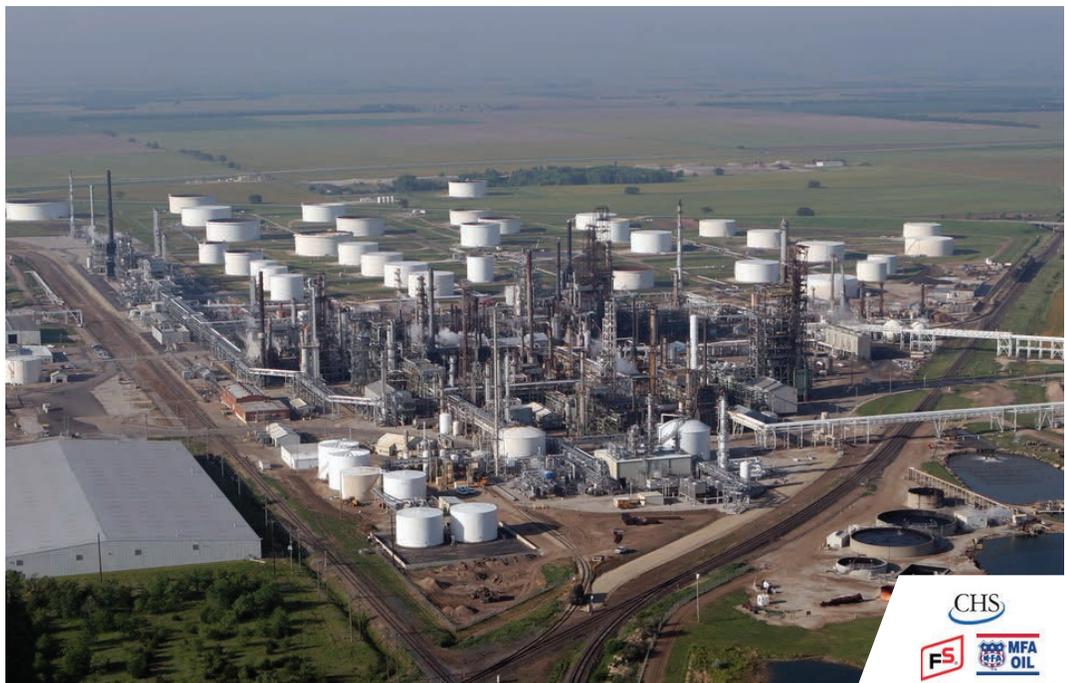
**Location of the leak:** Roof of gasoline storage tank. Repair replaced temporary patch.

**FTI Solution:** Instead, NCRA chose to contract Forge Tech, Inc. (FTI) to complete a mechanical repair using FTI's patented Portable Friction Bonding (PFB) application. This repair was completed in-service over two days. The FTI team installed 3/16" thick deck plates over each leak as shown in detail on the next page. The PFB application bonds metal studs at a low temperature that does not produce any sparks or flame and does not generate enough heat to meet the API-2207 definition of "Hot Work". Thus, this work was completed without the tank having to be decommissioned or de-gassed.

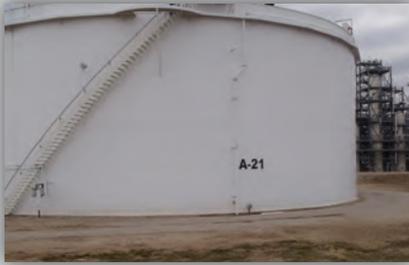
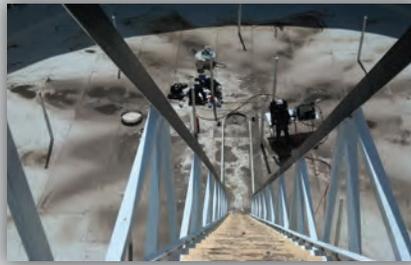
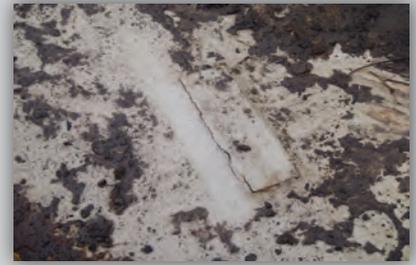
- Prepare the site
- Affixing studs
- Install 3/16" thick deck plate
